Residual Risk

An Account of Events in Nuclear Power Plants Since the Chernobyl Accident in 1986

May 2007

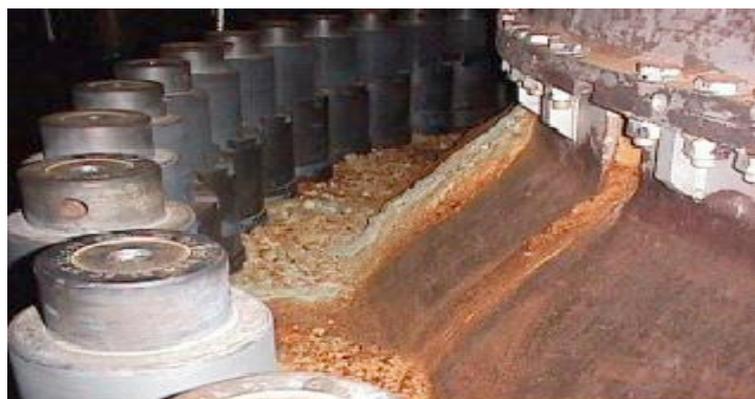
Rust-laced boric acid 'river' flowing through inspection ports on the reactor head and down onto the reactor flange during the refueling outage in 2000.

When the leaked water evaporated, it left behind dry boric acid crystals. Boric acid is very corrosive to carbon steel. It began eating through the carbon steel head. By 2002, there was a pineapple-sized hole in the head. The boric acid had completely eaten through the 150mm thick carbon steel wall to expose the stainless steel liner. The liner was applied to the inner surface of the carbon steel reactor vessel and head for protection against the corrosive borated water. The liner was not intended to be pressure-retaining, but for years it was the only barrier preventing a loss of coolant accident. As boric acid widened the hole, the stress loading of the liner increased. A government study estimated that the hole would have widened to the point where the liner ruptured in another 2 to 11 months of operation by Davis-Besse. Because Davis-Besse ran 18 months between refueling outages, had the damage been missed during the 2002 outage, it seems likely that a loss of coolant accident would have occurred.

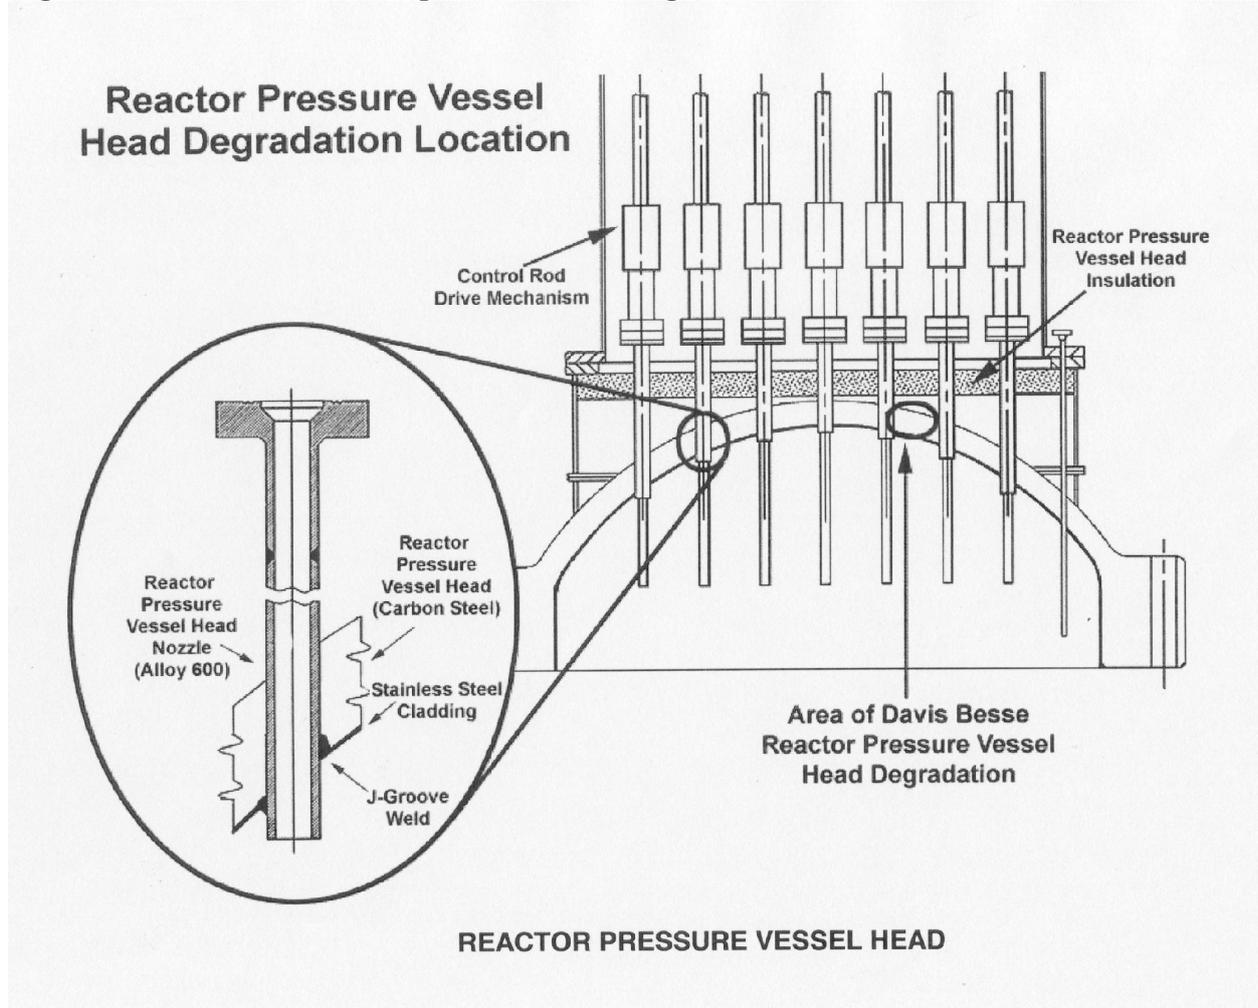
Figure 8: Davis Besse reactor pressure vessel degradation

On 6 March 2002, workers discovered significant corrosion in the carbon steel reactor vessel head at the Davis-Besse pressurized water reactor in Oak Harbor, Ohio. The head is bolted onto the reactor pressure vessel containing the reactor core during operation. There are sixty-nine holes in the head that allow control rods inside the reactor vessel to be connected to their external motors. There are stainless steel tubes, called control rod drive mechanism nozzles, through each hole and welded to the stainless steel inner liner of the head. It is believed that one of these tubes developed a crack around 1991. By 1996, the crack extended all the way through the metal wall of the control rod drive mechanism nozzle and began leaking borated reactor coolant water. The leak rate was small, less than 1 gallon per minute, but it persisted for nearly 6 years.

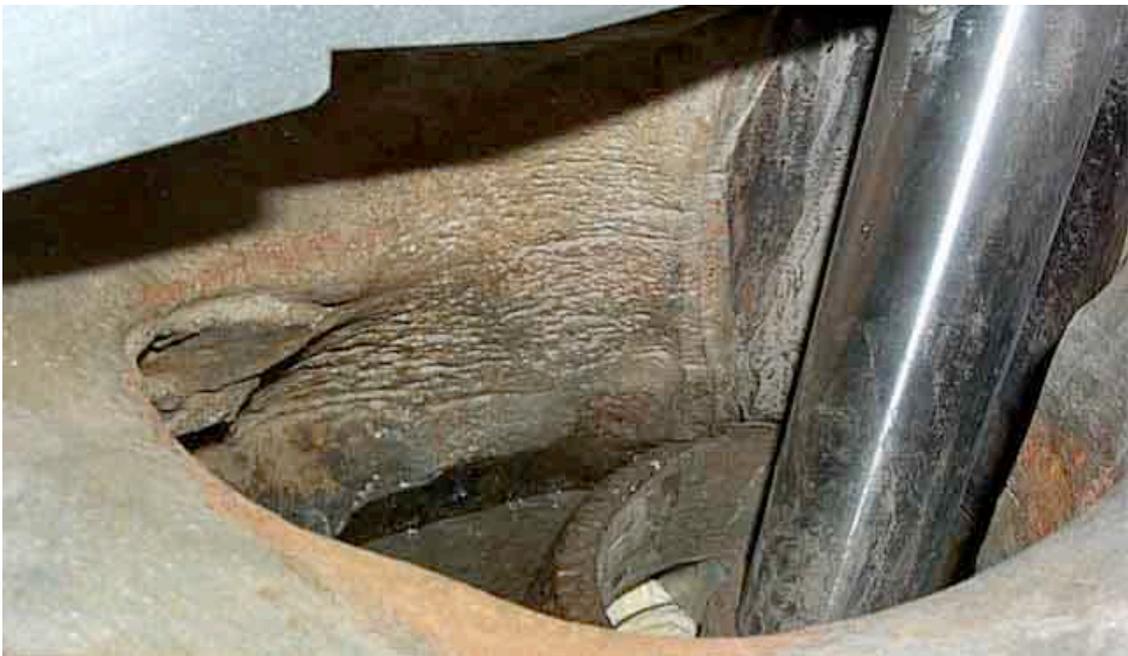
Had the 5mm stainless steel liner ruptured, a hole with a diameter of approximately 250mm would have created a medium-sized loss of coolant accident. While Davis-Besse was equipped with emergency systems to mitigate such an accident, these backup systems were also found to be impaired. The worst problem involved the containment sump used during the second phase of accident mitigation. In the first phase, emergency pumps transfer water from a large storage tank adjacent to the containment building into the reactor vessel to compensate for the cooling water pouring out the 250mm diameter breach. The water pouring out of the reactor drains to the bottom of the containment building where it collects in a concrete pit called the containment sump. Before the storage tank empties in about 30 to 45 minutes, the operators realign the emergency pumps to take water from the containment sump and send it to the reactor vessel. Workers found that the debris created by water jetting out through the hole (e.g., insulation and coatings scoured off piping and components) in addition to pre-existing debris inside containment (e.g., paint applied to the inner surface of the containment dome

The large hole in the reactor vessel head around the vessel head nozzle.

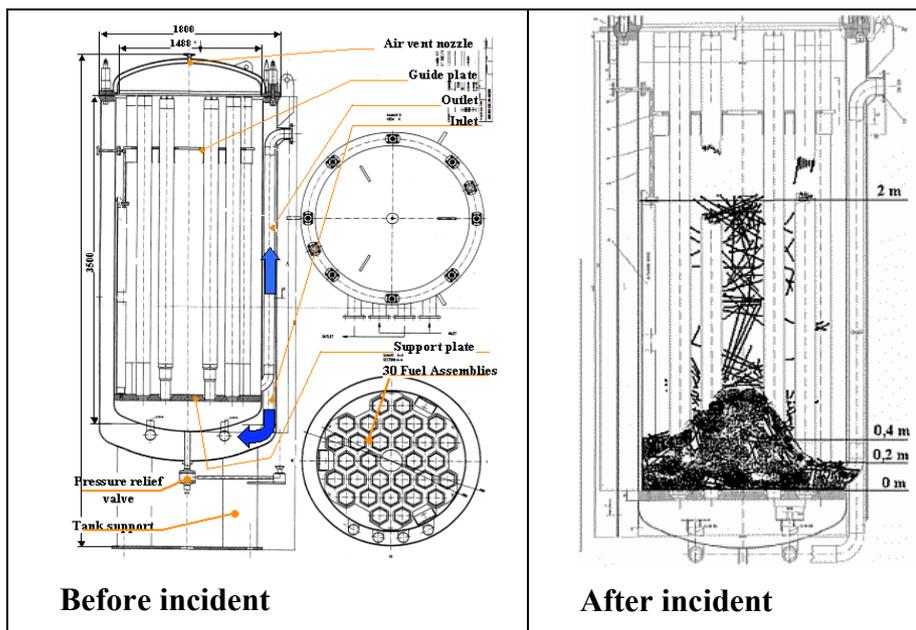
Figure 9: Paks Fuel Cleaning Tank Before and After the Incident

- Location of a pressure relief valve at the bottom instead at the top of the tank, which led to malfunctioning of the cooling function;
- Inadequate sizing of the submersible pump, whose redundancy and back-up system was also inadequate. The low-capacity pump had to operate for several hours after completion of the cleaning which was clearly beyond its design specifications;
- The tank design did not assure precise positioning of the bottom end of the fuel assemblies in the cleaning tank;
- Only one fuel guide plate in the cleaning tank was utilized, which cannot assure proper alignment of the fuel assemblies. The possible bypass flows around the fuel assemblies – thus not fulfilling its cooling function – were not fully taken into account;
- Instrumentation, trend recording and alarms provided to detect off normal conditions were inadequate.

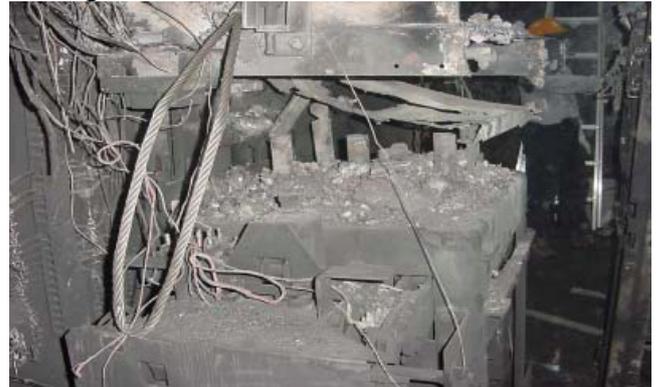
Damaged Breaker

Figure 11: Breaker Damage at Maanshan During Station Blackout

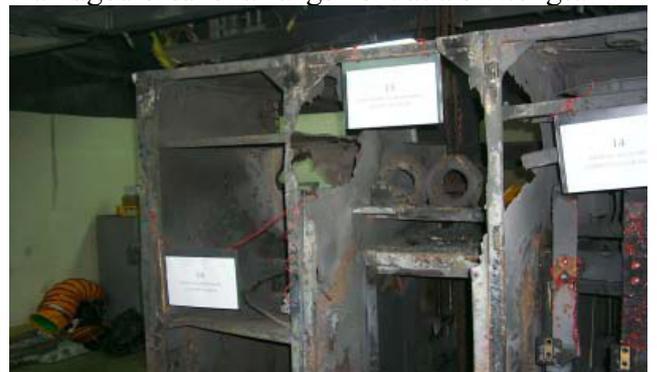
Damaged breaker arrangement at a switchgear
