Residual Risk

An Account of Events in Nuclear Power Plants Since the Chernobyl Accident in 1986

May 2007

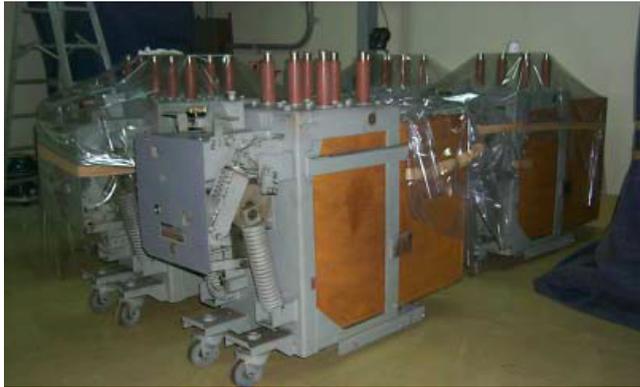
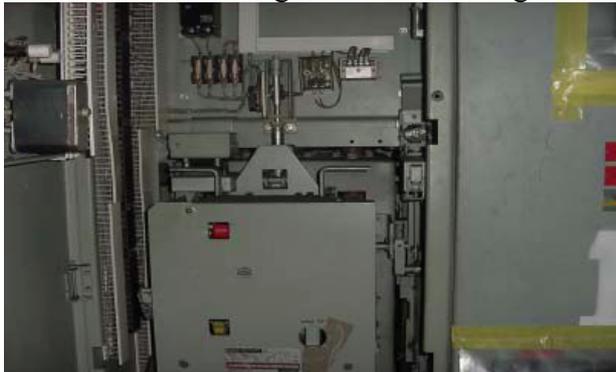
Figure 11: Breaker Damage at Maanshan During Station Blackout

It turned out that the operator should have declared the event much earlier, as soon as the station blackout situation occurred. The breaker fault at the 4 kV essential bus is considered as the main cause of the event. The breaker and the switchgear got totally destroyed by the fire (see figure 11).
